HOW ARE YOUR RINGS?

CAPSULE EJECTORS FOR VOLKMANN

REPLACING TIMING BELTS AND GEARS

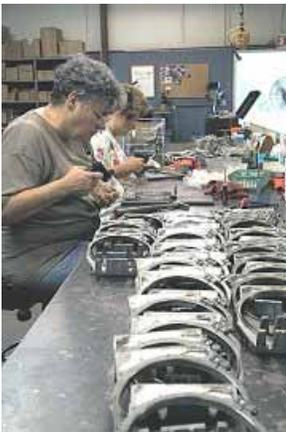
Simple solvent washing or ultrasonic cleaning by the plant only cleans the exterior of the ring and does not internally clean the ring. Many plants have attempted internal cleaning and almost none have succeeded; those that have succeeded have abandoned in-house cleaning because of the OSHA requirements on the use of strong reagents and EPA requirements on disposal of contaminants.

The Epic process of internal cleaning involves a complex series of chemical processes resulting in a certified, clean, and “like-new” ring. Epic Ring Service is the only full-service agency in the Americas cleaning rings and certifying its work with a Porosimeter. Rings are separated from the holders and chemically cleaned to new ring standards. Holders are also disassembled, cleaned and rebuilt with new parts (windows, buttons, springs, wicks, etc.). When required, rings are refaced. Also when required, broken or damaged rings are replaced with good rings, so that the plant receives back a full frame of “like-new” assemblies.
